ANALYSIS OF ELECTRICAL FAULTS IN THE CRANE HOISTING CONTROL PANEL AT THE SEI DAUN PTPN 3 PALM FACTORY

ABSTRACT

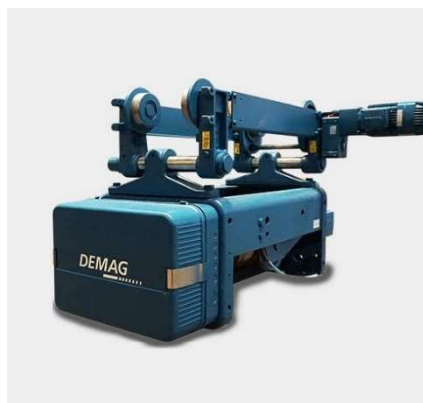
Figure 1. Hoisting Crane

The Hoist Crane electric motor is the type of motor that is most widely used in industry, one of which is the Hoist motor as a Hoist drive motor in the production building, packing building, and warehouse, which aims to move an item (load) where the load is in the form of a lorry containing ripe FFB. According to how it works, the Hoisting Crane at Sei Daun PKS has 3 Electromotors, which have their respective movements: the Hoist, Traveling, and Tilting.

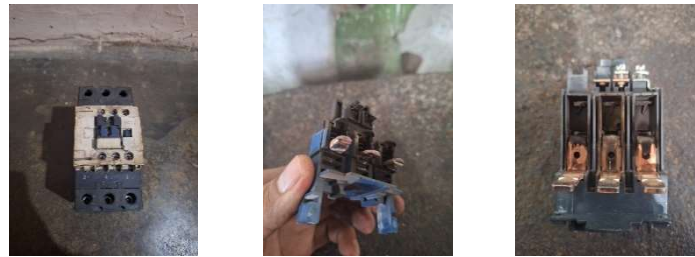
Figure 5. Damaged contactor

The contactor damage to the Hoisting Crane control panel is urgent, so it needs to be dealt with quickly so that the production process is not hampered. From the results of the data from the technician, there is a possibility that the factor causing the disturbance is a current surge, which causes the current passing through the contactor to exceed its current rating value so that Excessive heat arises, which causes the contactor to glow/melt as seen in the picture below.

However, a possible factor still causes this problem, namely, loose contactor bolts installed due to lack of maintenance on the control panel.

Date	Friday, September 15th, 2023
Time	09.00 wib
Priority	Urgent
Disorder Description	Hoist motor buzzing, no power
Cause	Contact K2 loss contact 1 fasa
Effect	Hoisting Crane cannot operate
Handling	Replace damaged contactors
Normal condition	Voltage fasa = 380 - 400 V Current = R;25A S;25A T;25A Control voltage = 42 V
Disorder Conditions	Not operating (<i>Shutdown</i>)

The leading cause of damage to the contactor on the control panel is that the excessive current passing through the contactor to the electromotor is too large, causing excessive heat, which causes the contact pins to melt/glow.

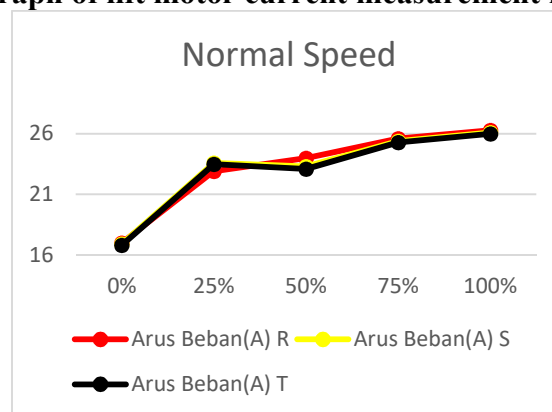
Table 10. Graph of lift motor current measurement results (Hoist)

Based on data on damage to the Hoisting Crane control panel on contactor damage, current measurements were carried out for each phase when lifting loads at slow and average speeds and when empty (0%), 25%, 50%, 75%, and complete (100%). The following is a table of measurement data and graphs.

Load Weight	Load Current (A)		
	R	S	T
0%	17	16.9	16.8
25%	22.9	23.6	23.5
50%	24	23.3	23.1
75%	25.6	25.4	25.3
100%	26.3	26.1	26

According to the calculation results of the current flowing in the electromotor from the equation above, the current flowing when the electromotor is loaded based on table (9) is considered normal because it is still below 27.8A, and based on the calculation results for the contactor rating in equation (2), the installed contractor for lift motors, as shown in the table

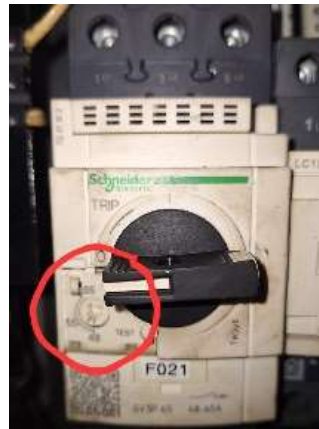
Figure 6. Setting overload

The protection device used on the Electromotor is a motor circuit breaker, which also functions as an overload limiter, as listed in table (2) "control panel components." When the current passing through the protection device to the motor when running exceeds the current rating on the safety, adjusted to the motor's nominal current, the protection device disconnects (trips). To determine the overload rating value for the hoist motor, use the equation below.

$$\text{Setting overload} = I \text{ nominal} \times 110 - 120 \% \quad (3)$$

$$\text{Setting overload} = 27,8 \times 110 \%$$

$$\text{Setting overload} = 30,58 \text{ A}$$

Description	Motor Breaker	Circuit	The calculation results
Setting rele proteksi	48 A		30,58 A

Based on the table above, the protection settings for the Motor Circuit Breaker are not the same as the calculation results for the overload protection settings (overload).

After analyzing the overload setting of the Lift Electromotor, it was found that the overload rating value had exceeded the nominal current value on the Electromotor, so it was unsuitable for use.
